NRL HYBRID RELIABILITY

PHYSICS OF FAILURE INITIAL STUDY

FINAL REPORT FOR
PERIOD 1 OCTOBER 1986 TO 30 SEPTEMBER 1988

NRL HYBRID RELIABILITY PHYSICS OF FAILURE INITIAL STUDY

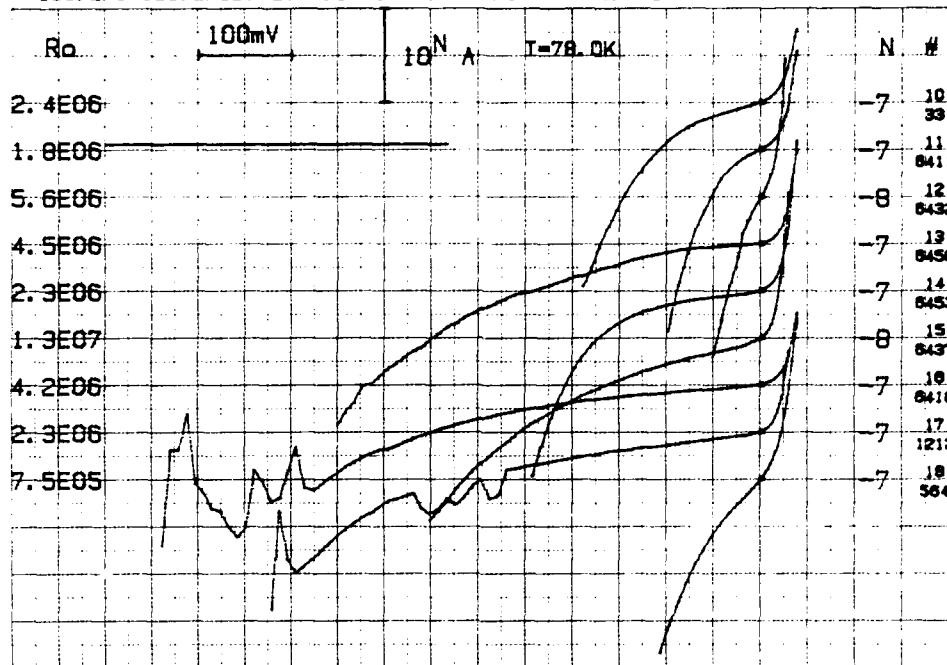
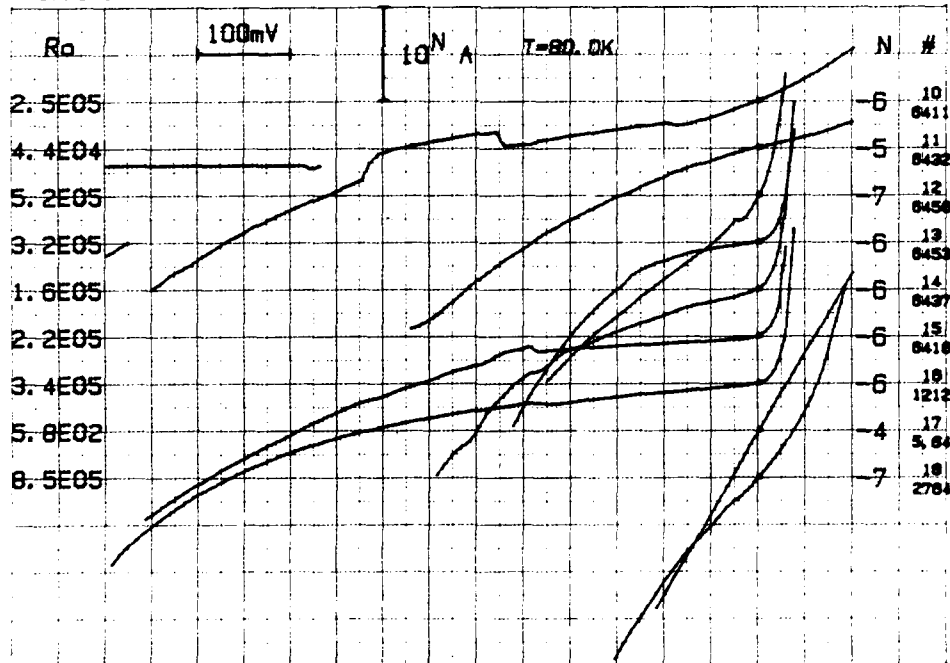
Figure 5-8. Zero Field-of-view Electrical Performance Unchanged by Hybridization at 35 lb. I-V curves typical of arrays viewing a cold scene show no degradation due to hybridization

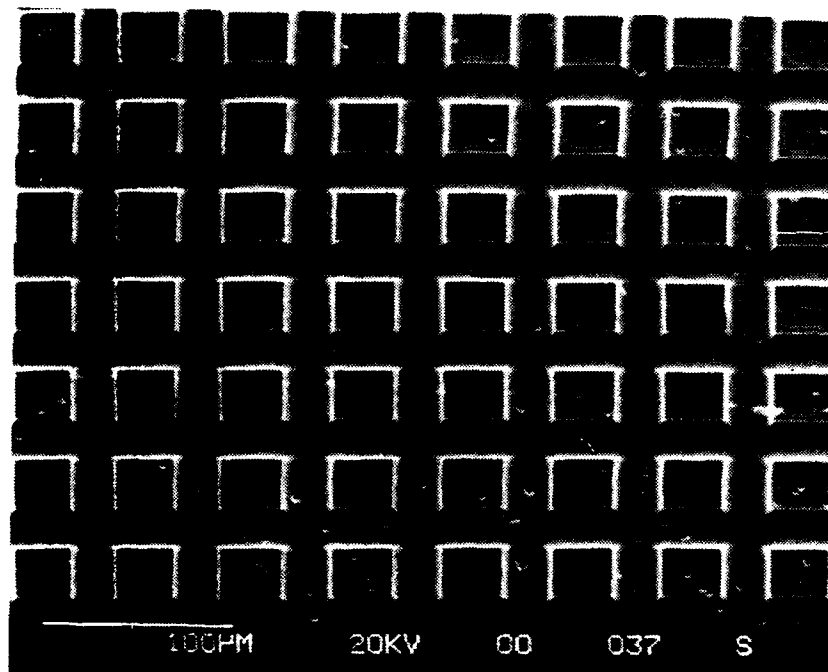
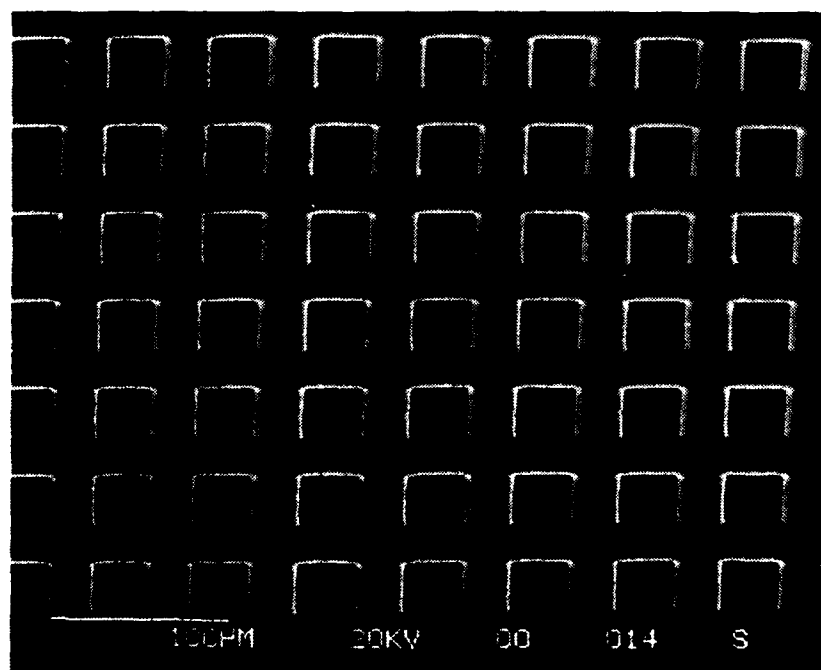
Figure 5-9. Etch Pit Density Not Affected by 200 Thermal Cycles. It can be seen that no increase in revealed dislocations occur as a result of 200 thermal cycles.

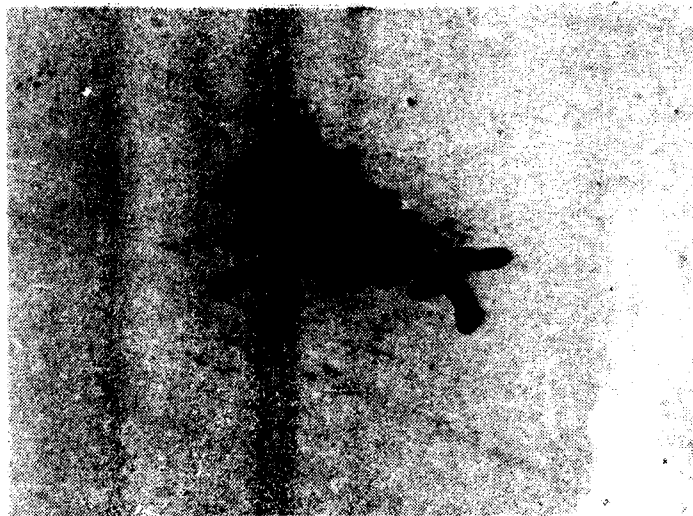
Micrographs of Etched HgCdTe Surface (500X) After Various Etch Times ($\text{H}_2\text{O}_2:\text{NH}_3\text{OH}$ 2:1,
(a) 10 min, (b) 15 min, and (c) 20 min.

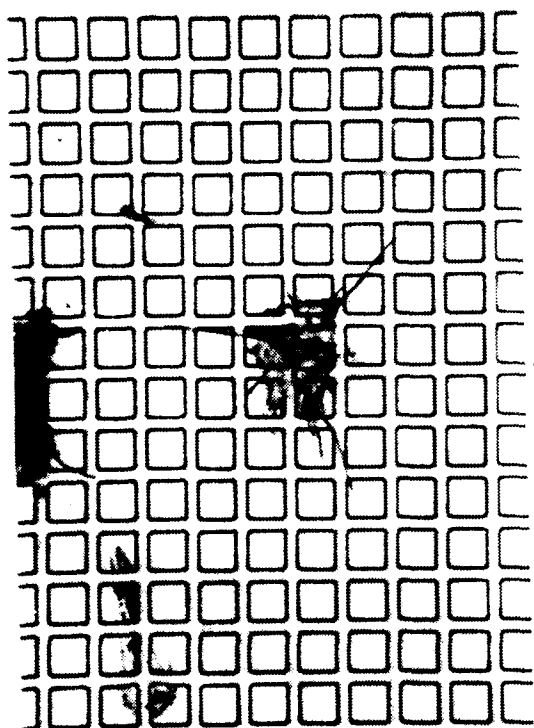
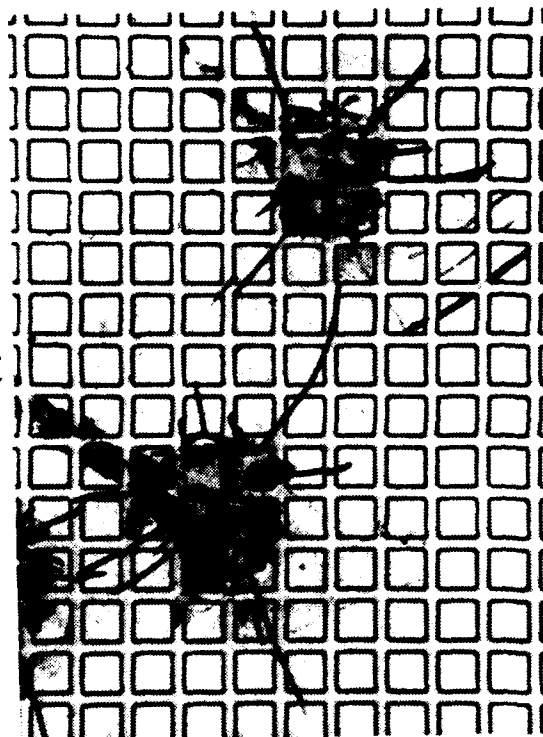
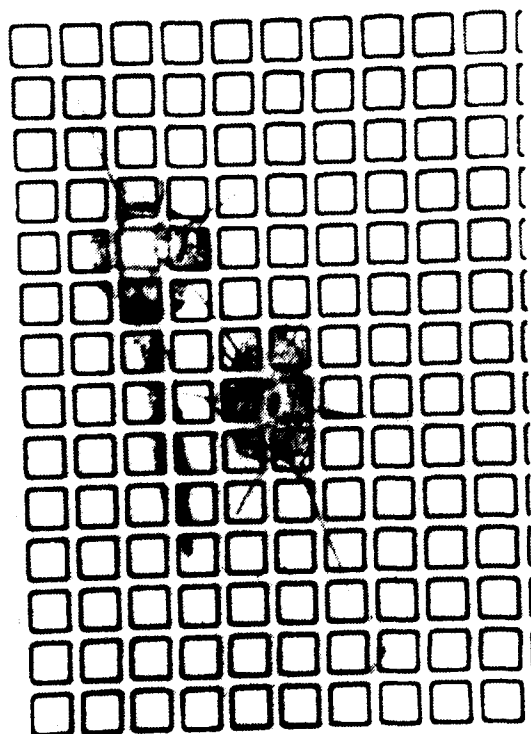
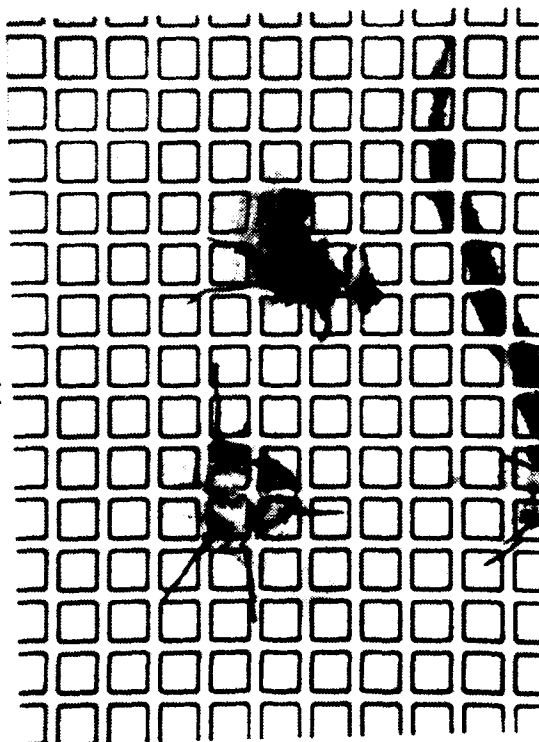
Micrographs of Etched HgCdTe Surface (200X) After Various Etch Times ($\text{H}_2\text{O}_2:\text{NH}_3$ 2:1, (a) 4 min, (b) 6 min, (c) 8 min, and (d) 10 min.

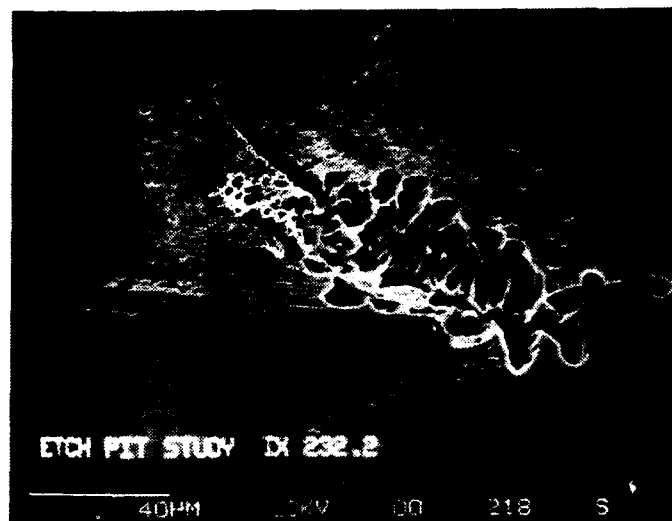
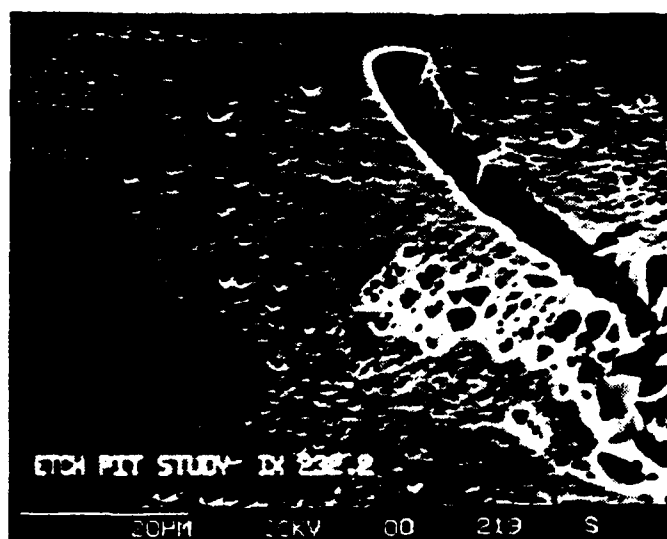
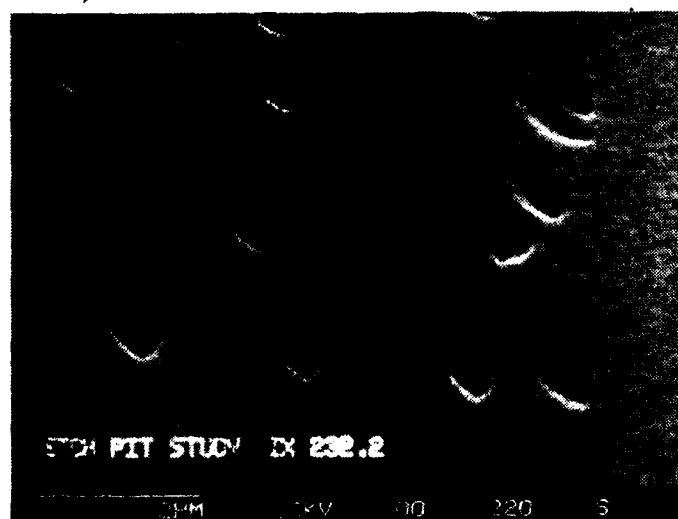
SEM Micrographs Showing Etch Pits on HgCdTe Surface After 10 Min Etch

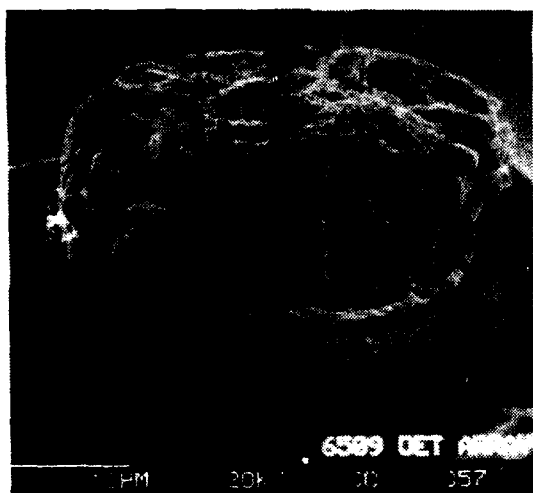
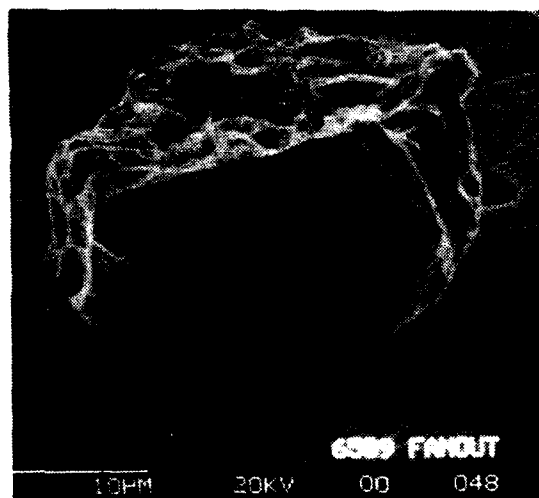
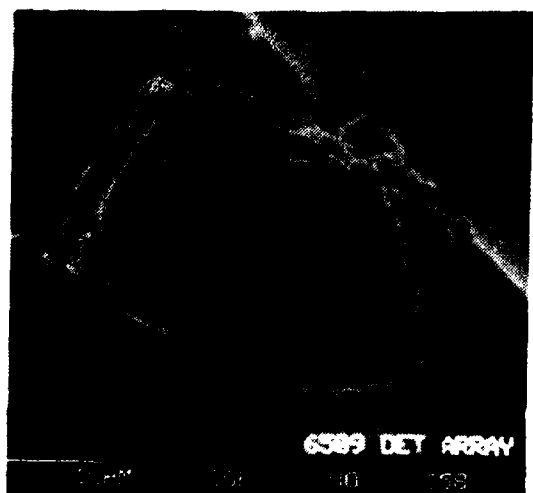
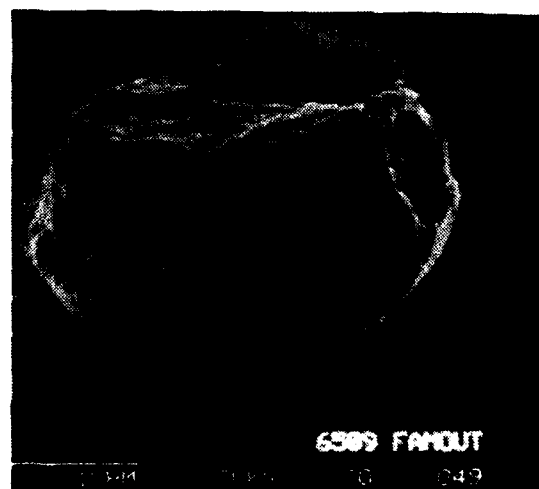
SEM Micrographs of Indium Bumps on Diodes and Fanout Metallization for (a) Diode 42 (b) Fanout for Diode 42, (c) Diode 43, and (d) Fanout for Diode 43

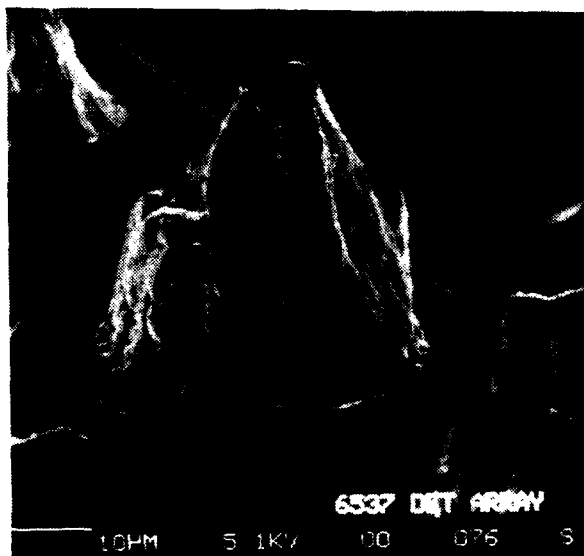
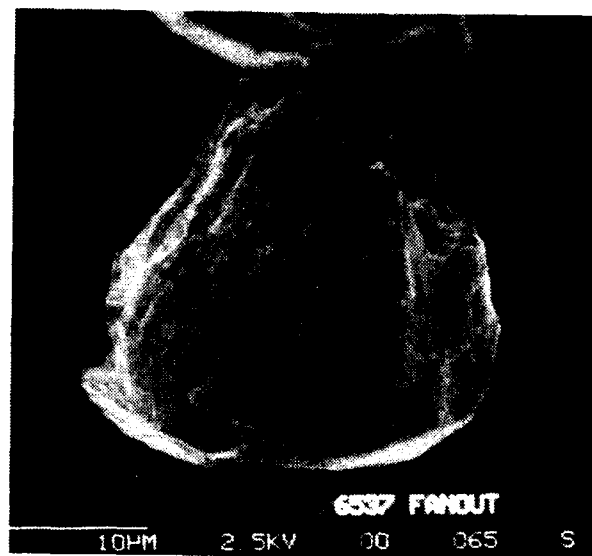
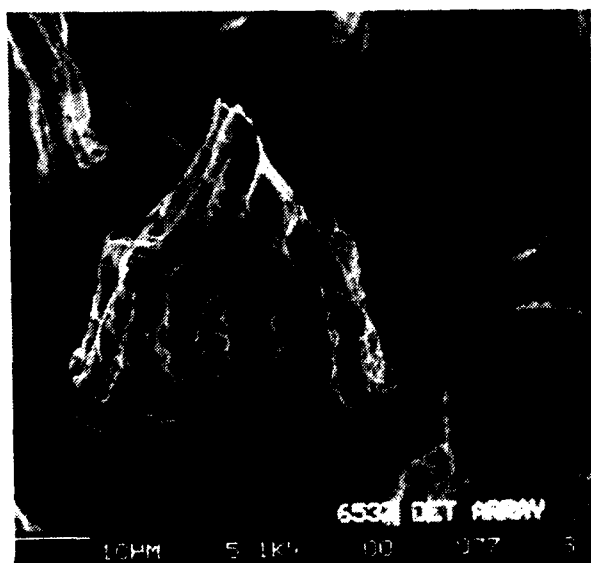
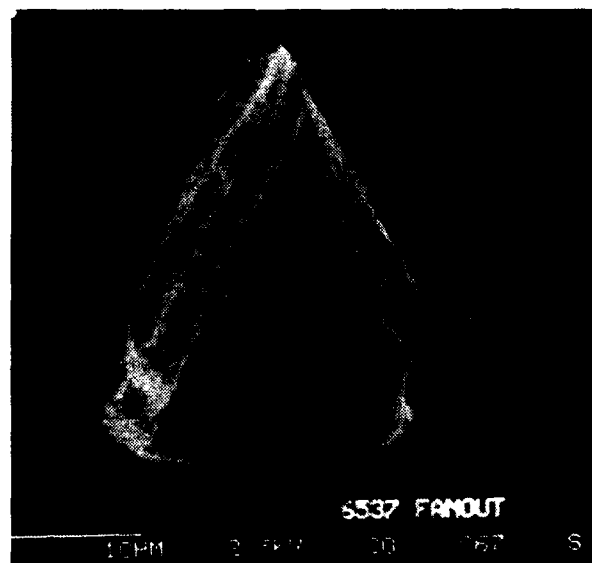
SEM Micrographs of Indium Bumps on Diodes and Fanout Metallization for (a) Diode 9 (b) Fanout for Diode 9, (c) Diode 11, and (d) Fanout for Diode 11

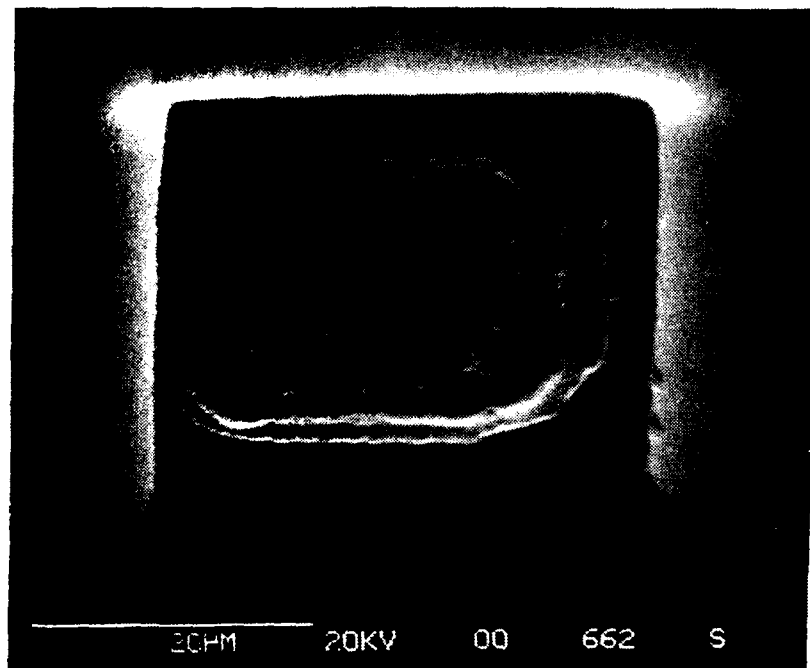
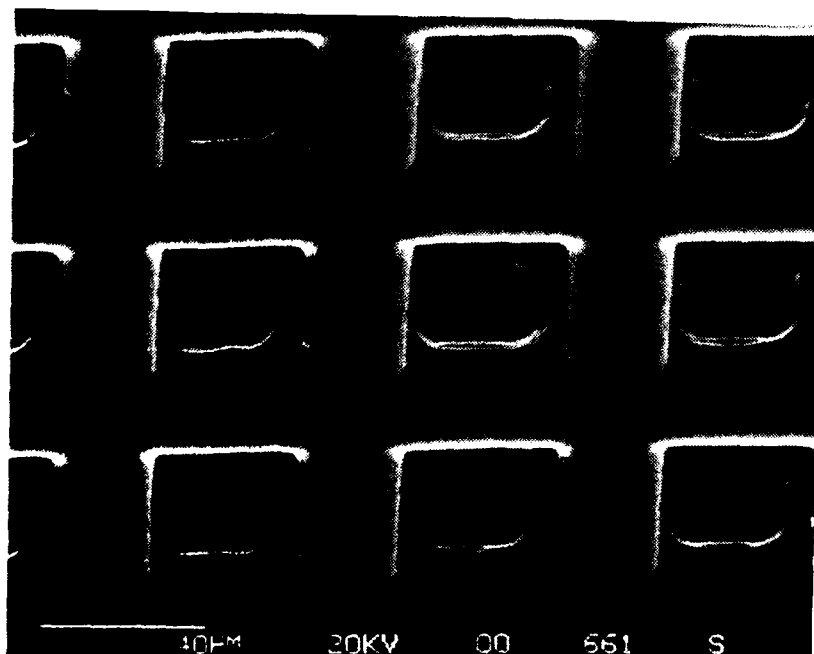
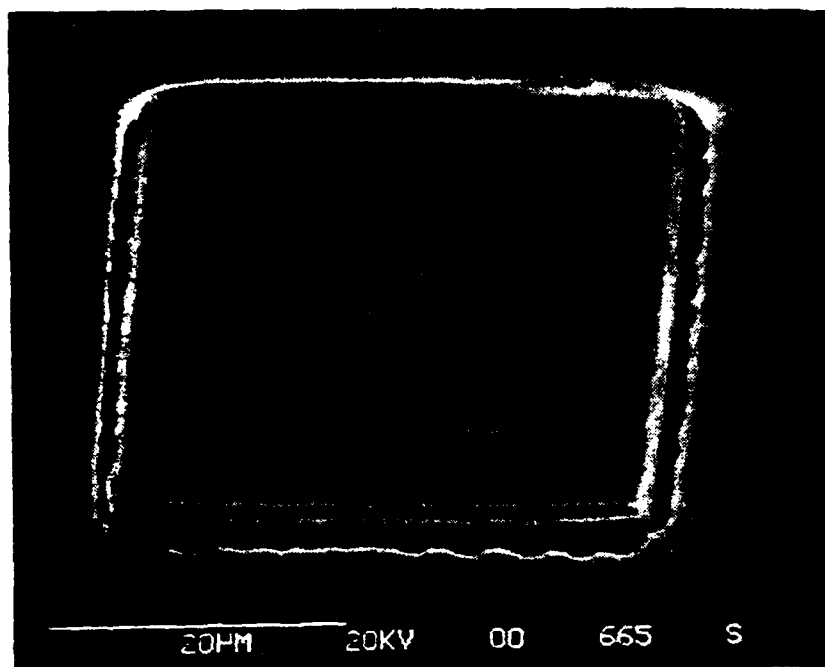
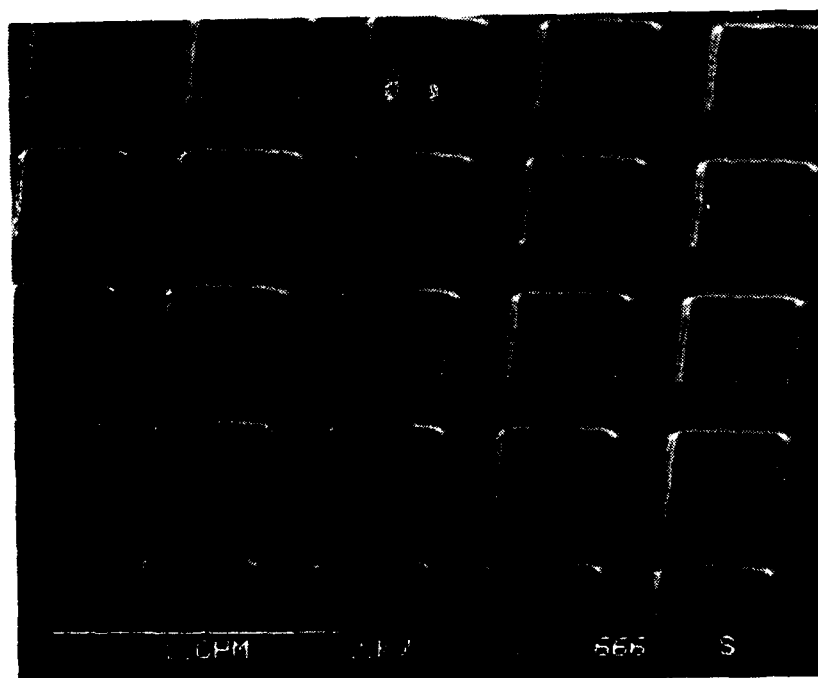
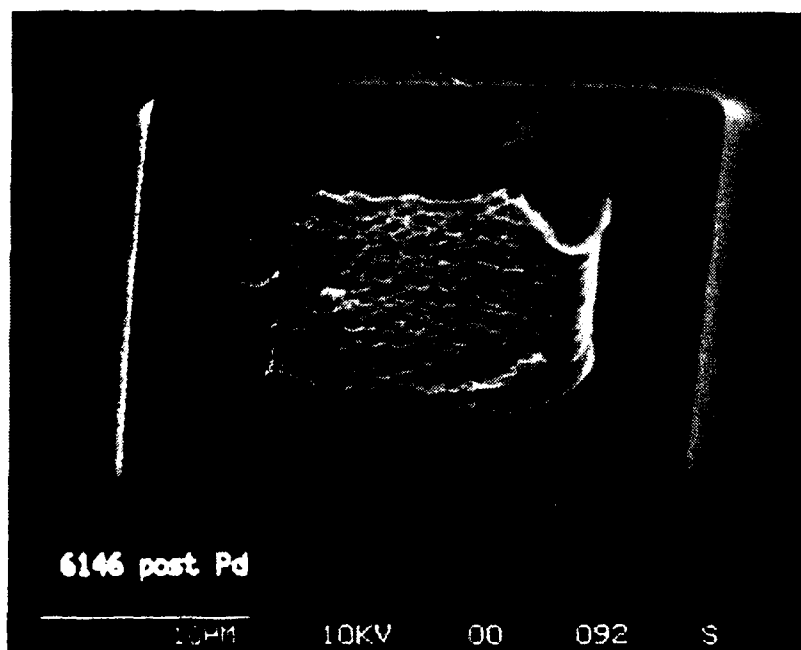
SEM Micrographs of HgCdTe Mesa Diodes After Etching of Pd Metallization

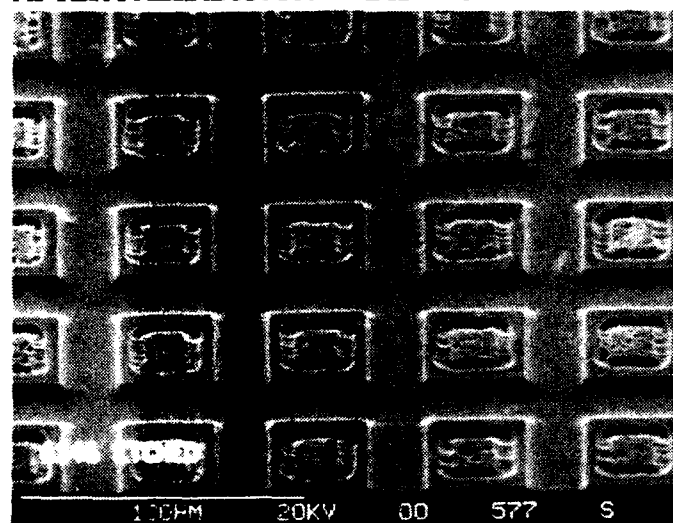
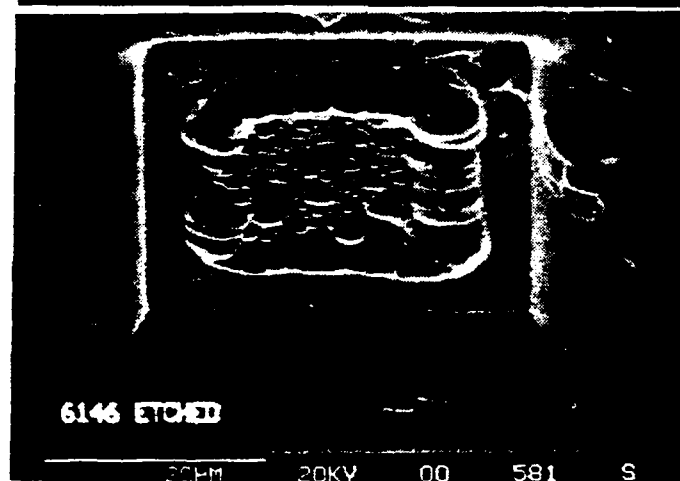
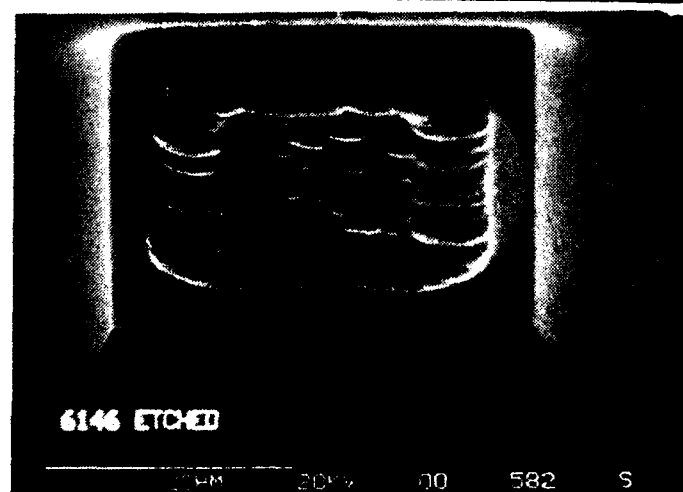
SEM Micrographs of HgCdTe Mesa Diodes After First Etching to Remove Pd and Then to Delineate Etch-Pits

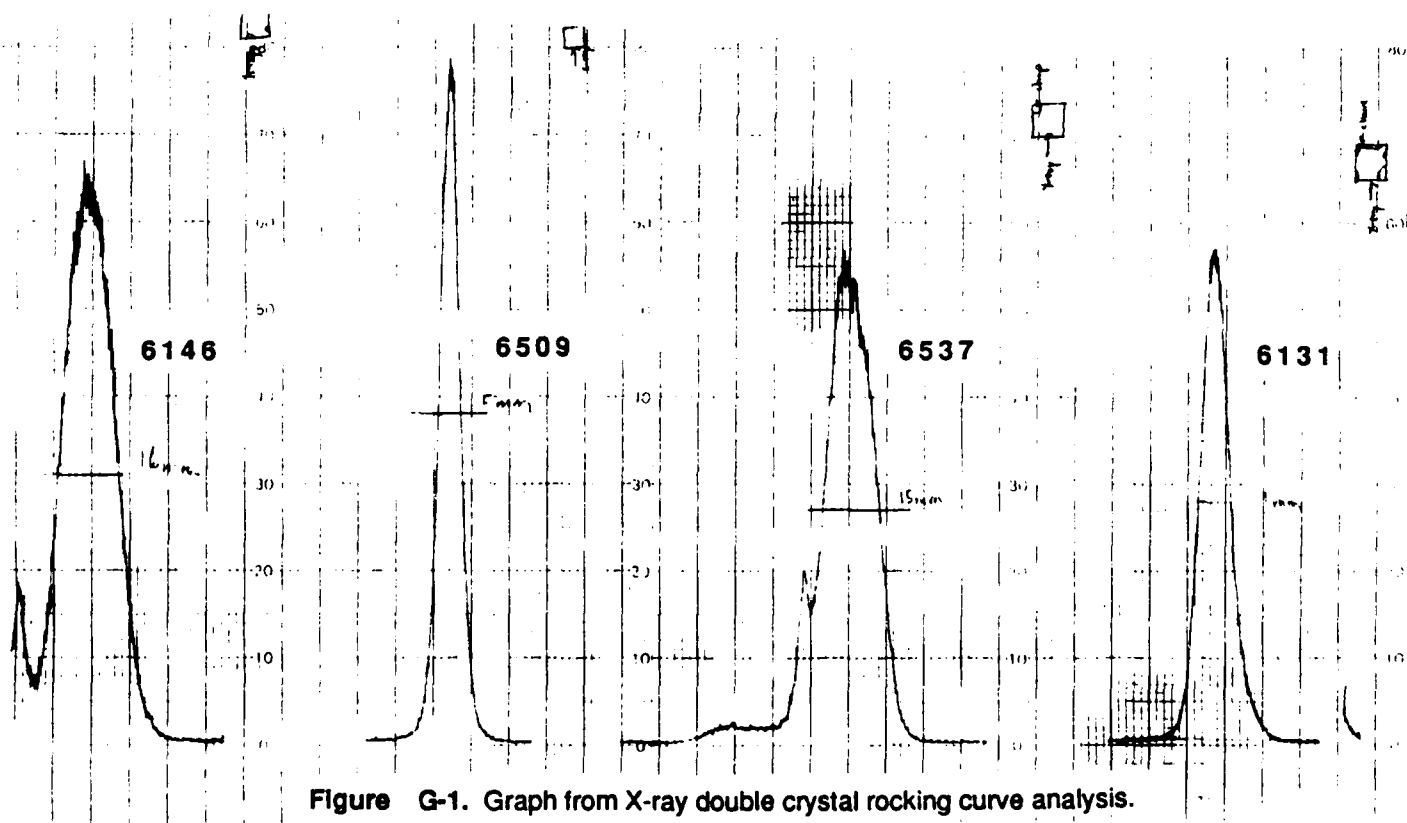
Figure G-1. Graph from X-ray double crystal rocking curve analysis.

Analysis was performed on four parts after thermal cycling. The results of analysis are shown in Appendix G. No correlation could be made between the number of thermal cycles and substrate degradation. The best quality material, as measured by rocking curves, was assembly 6509, that had been cycled 200 times.
